Portage Creek Sediment Remediation Project Kalamazoo, Michigan

Pre-Sediment Removal Structure Feature Assessment
Removal Areas SA1-A, SA1-B and SA1-C

F&V Project Number: 809930
May, 2013

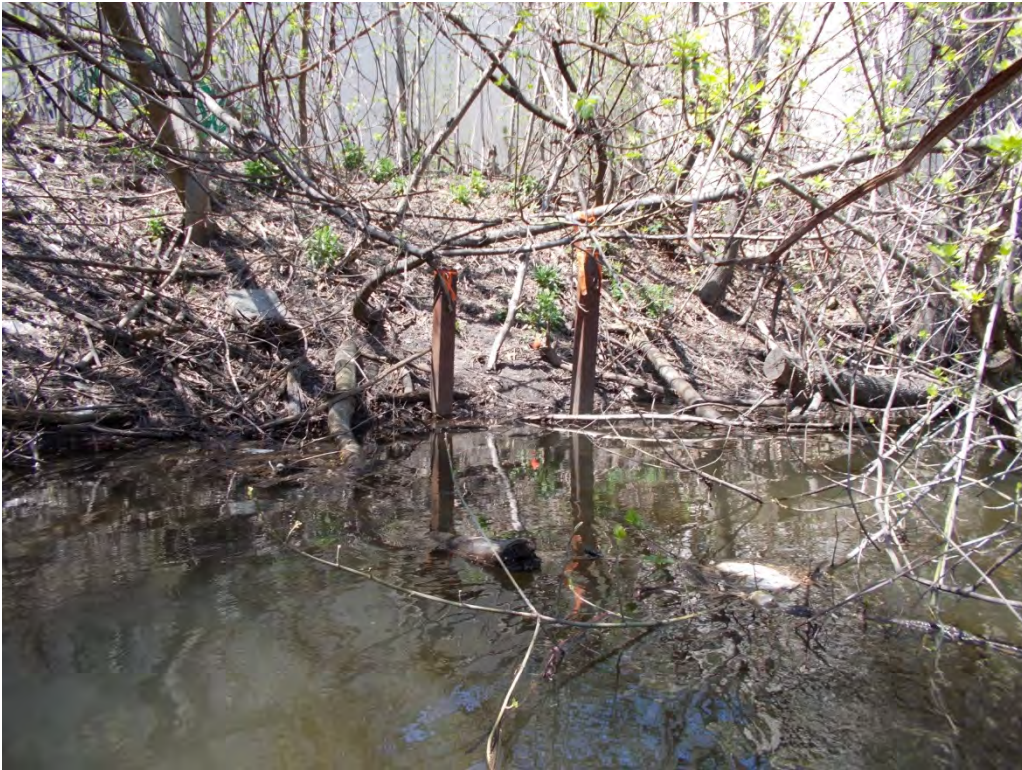
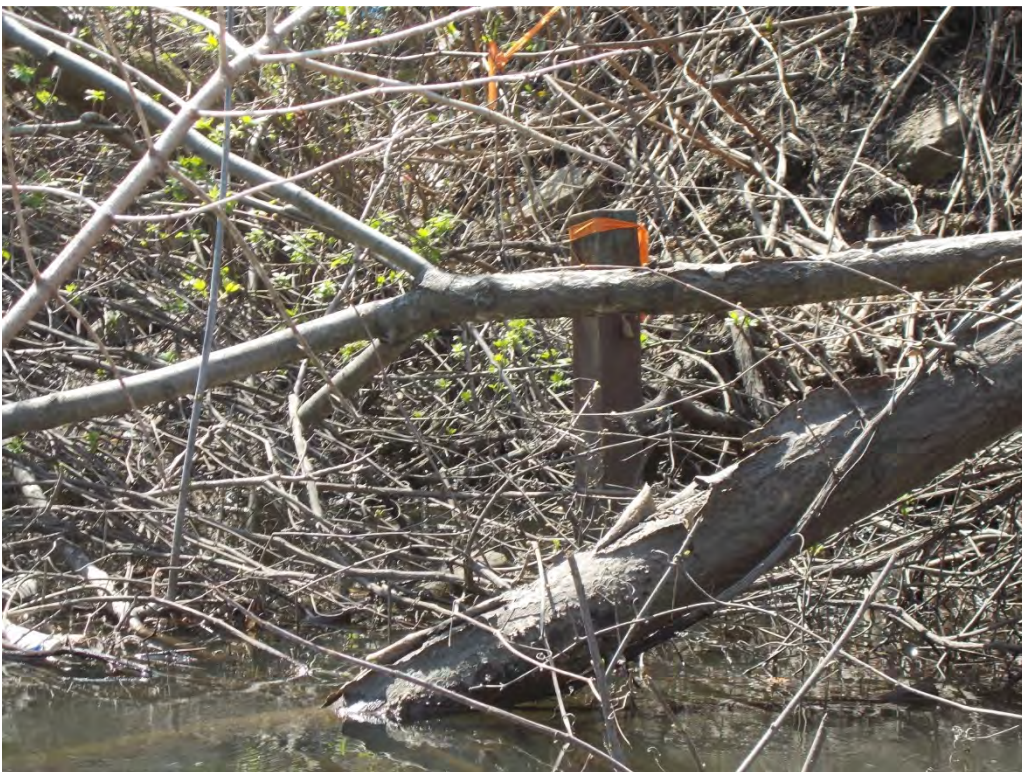
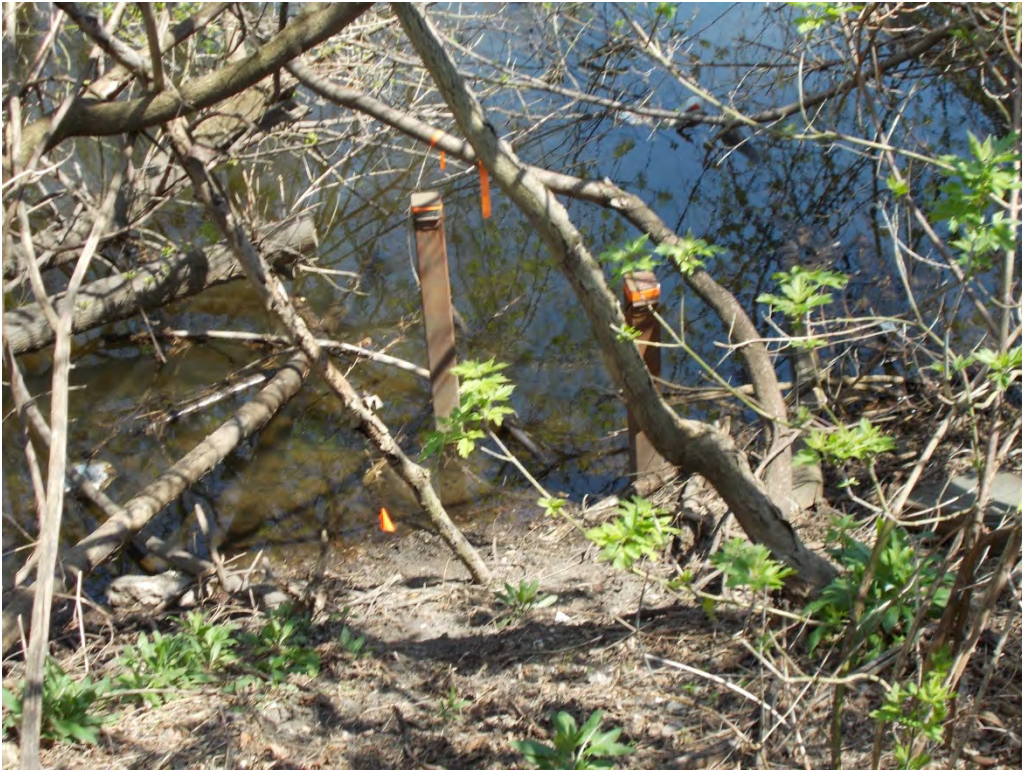
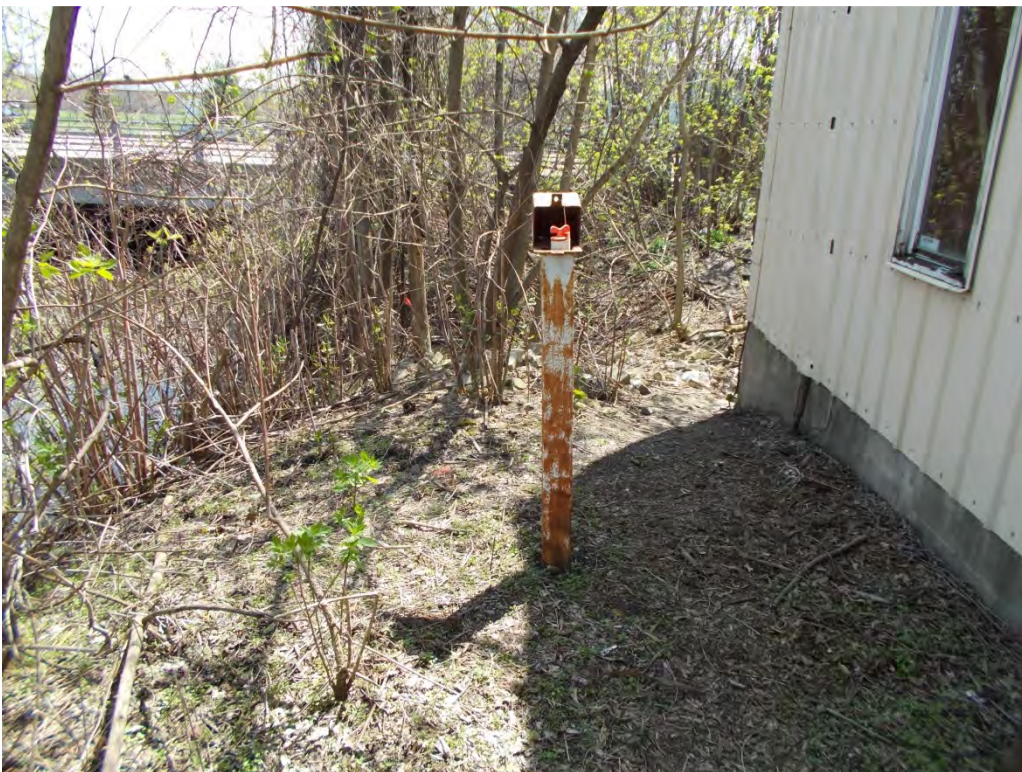
- The structures are in fair to good condition and are located with orange flagging.

View of structures from the channel

View of structure from the channel

View of structures from top of bank

View of structure at top of bank looking south

- Protect the monitoring wells as directed by the USEPA.

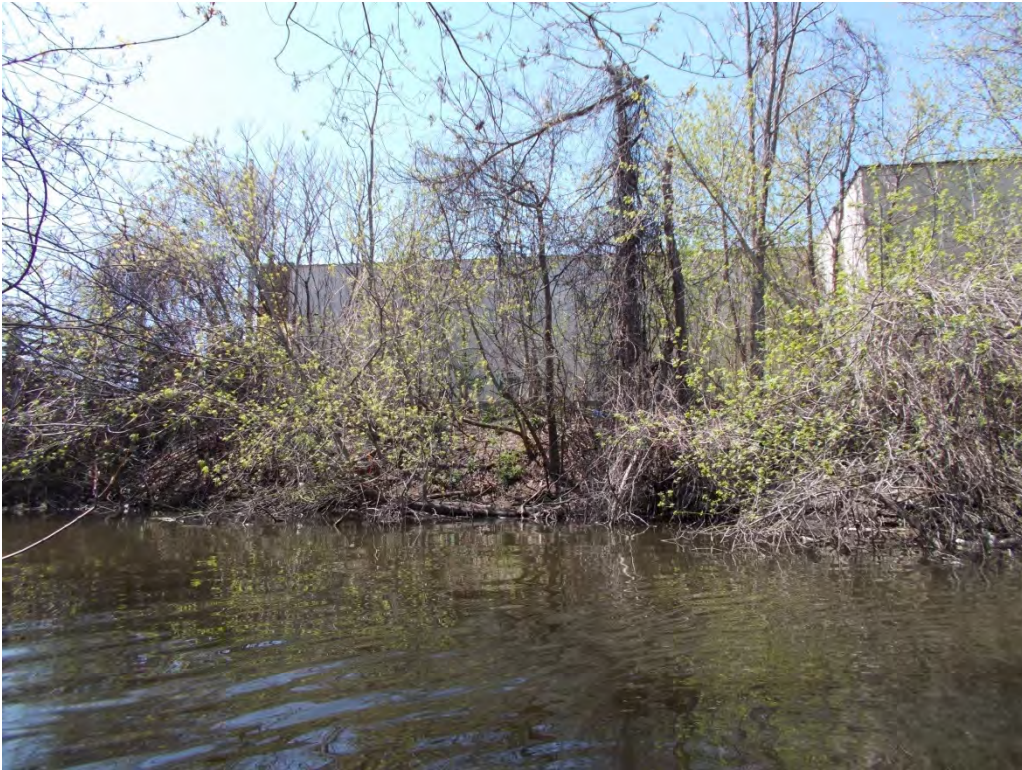
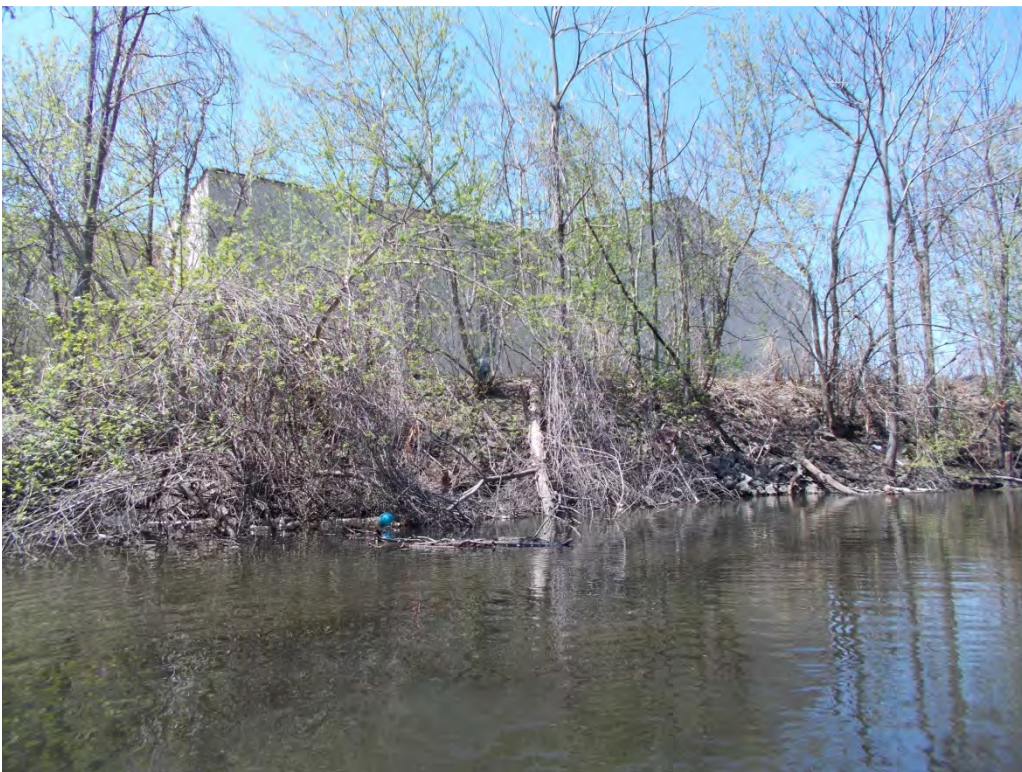
- The brick extension wall in the southeast corner has severe horizontal cracking at a mortar joint.
- The concrete foundation appears to be in fair condition.
- The aluminum siding appears to be in fair condition.
- The wood window trim is severely rotted.
- A significant amount of brush growth was noted behind the siding.
- The concrete and asphalt pavements on the north side of the building are severely deteriorated. The asphalt in particular has failed, apparently due to dumpster access.

View of structure from the channel

- The building appears to be outside the influence of the sediment removal. Operators and drivers should use due care when working around the building to avoid damage from equipment.

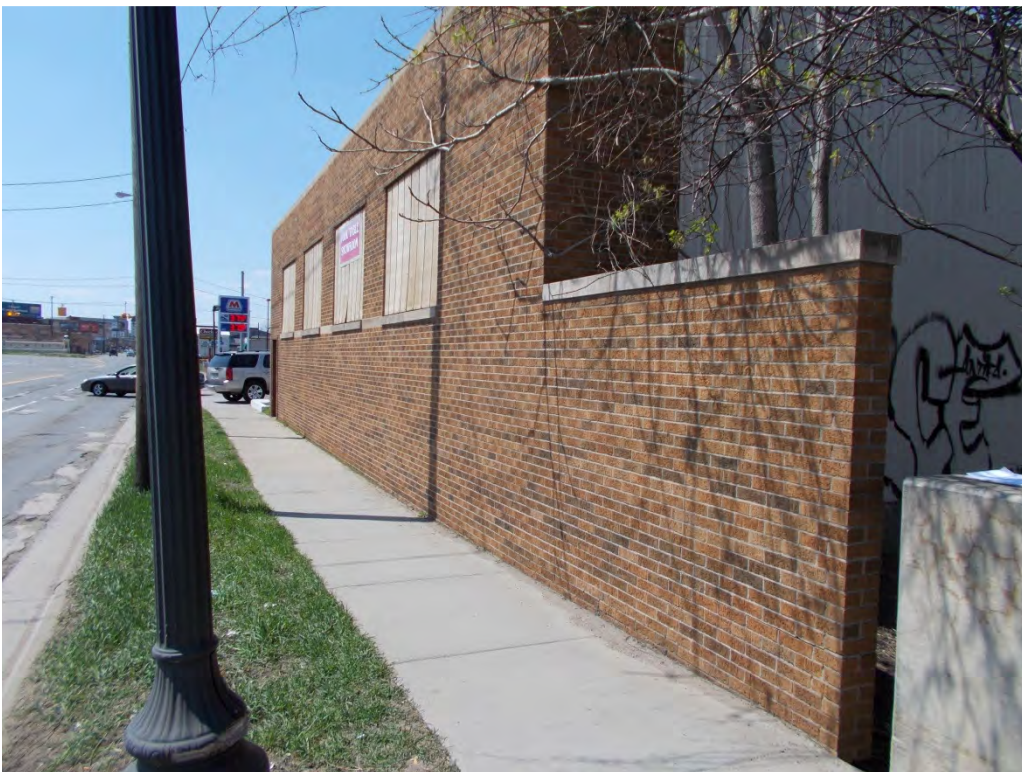
View of brick façade on south side of structure

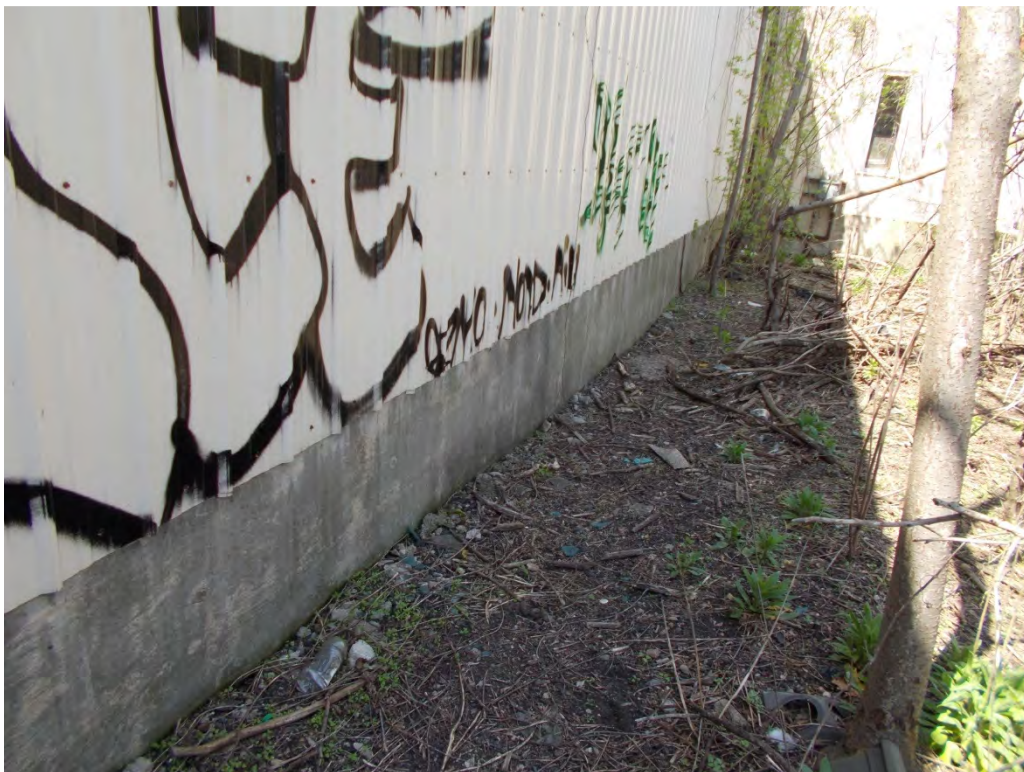
View of southeast foundation wall and siding

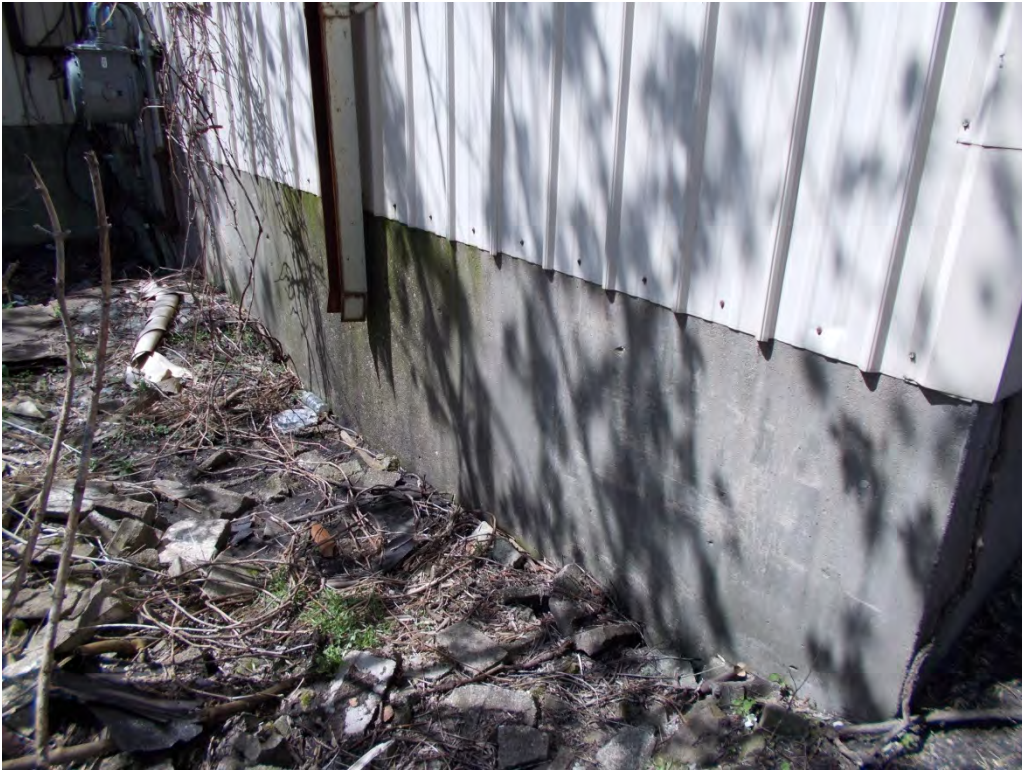
View of foundation wall and siding

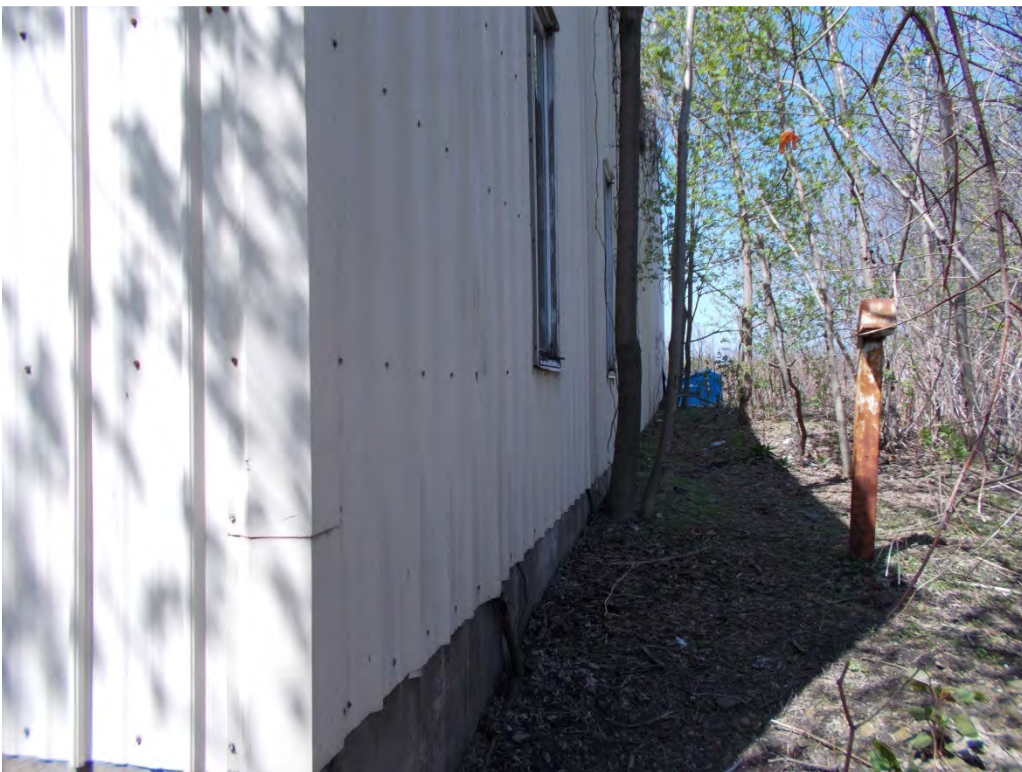
View of northeast wall of building

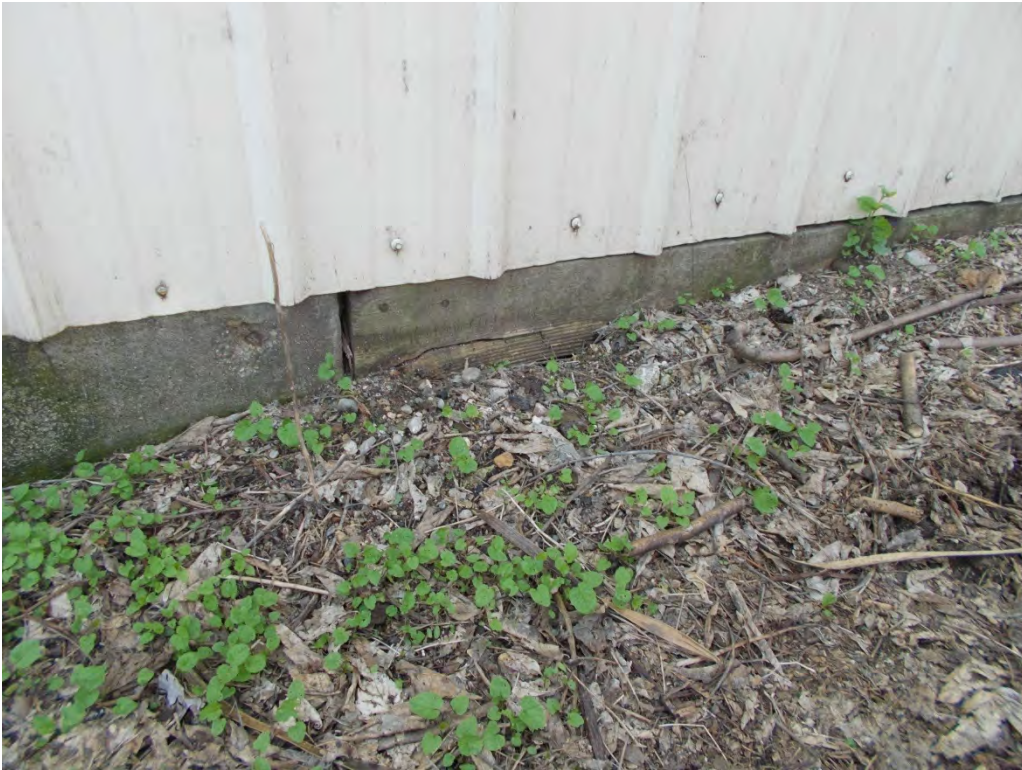
Transition between concrete foundation wall and unknown foundation

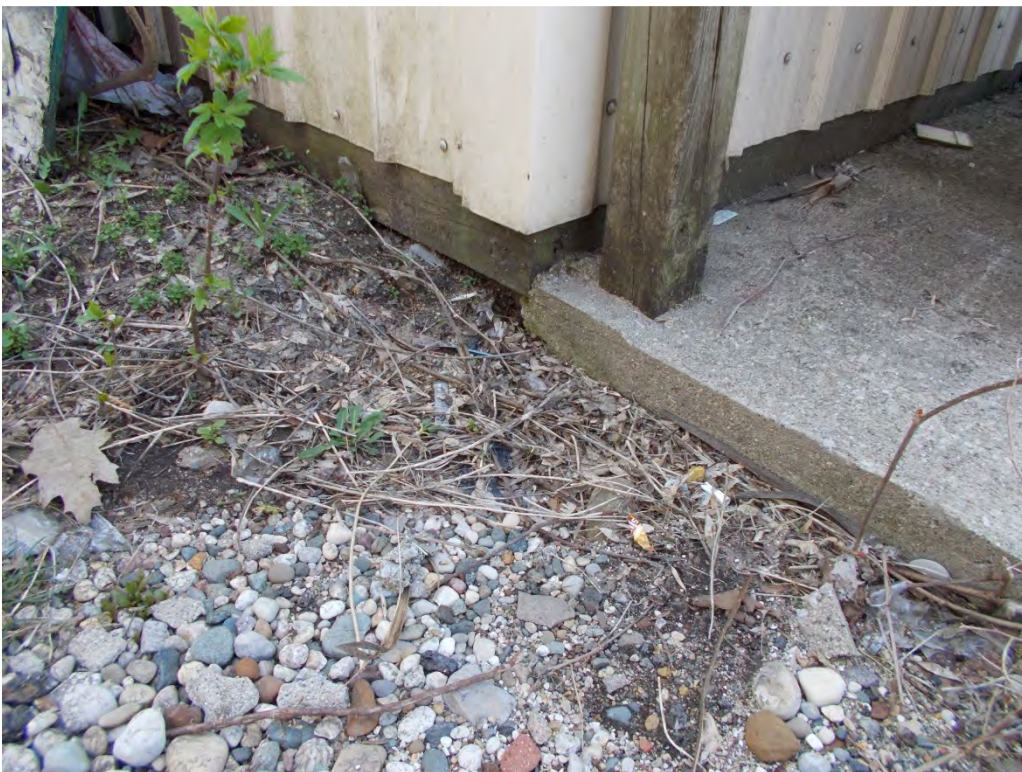
Washout around northeast corner of building

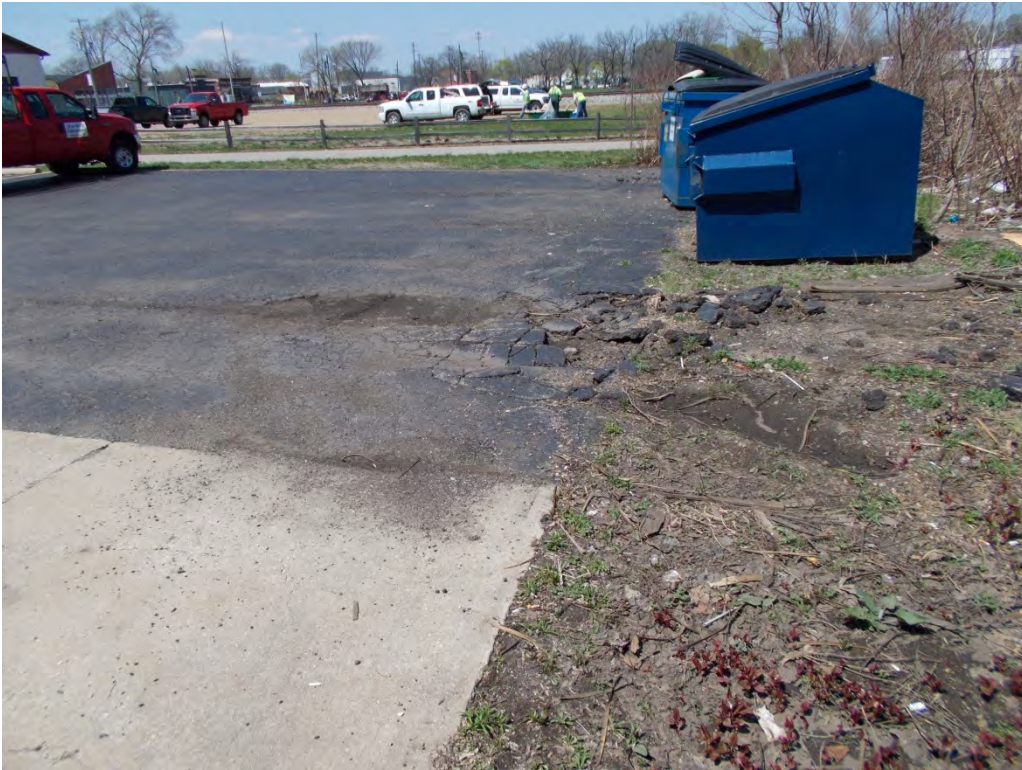
Failure of asphalt pavement near dumpsters

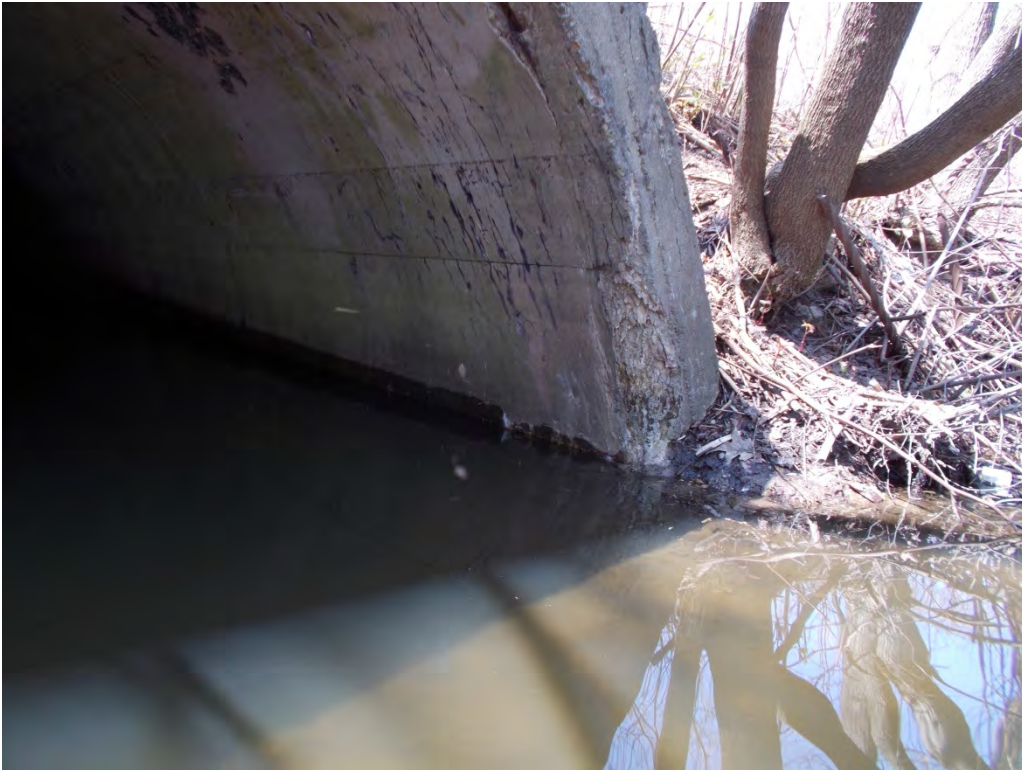
- There is a spalled area with exposed steel on the north side of the interior.
- The concrete has efflorescence and delamination along the waterline.
- Minor to moderate cracking was noted in the soffit area.
- The majority of the structure appears to be in fair condition.
- Assuming the structure is a complete circular section, the invert of the pipe appears to be approximately 2-3 feet below the bottom of the channel.

Efflorescence and delamination near the waterline

- The structure should be isolated from the creek during sediment removal to allow for dewatering. A minimum clearance of 3-4 feet is recommended for a sheet pile cofferdam, if that is the selected method of isolation.

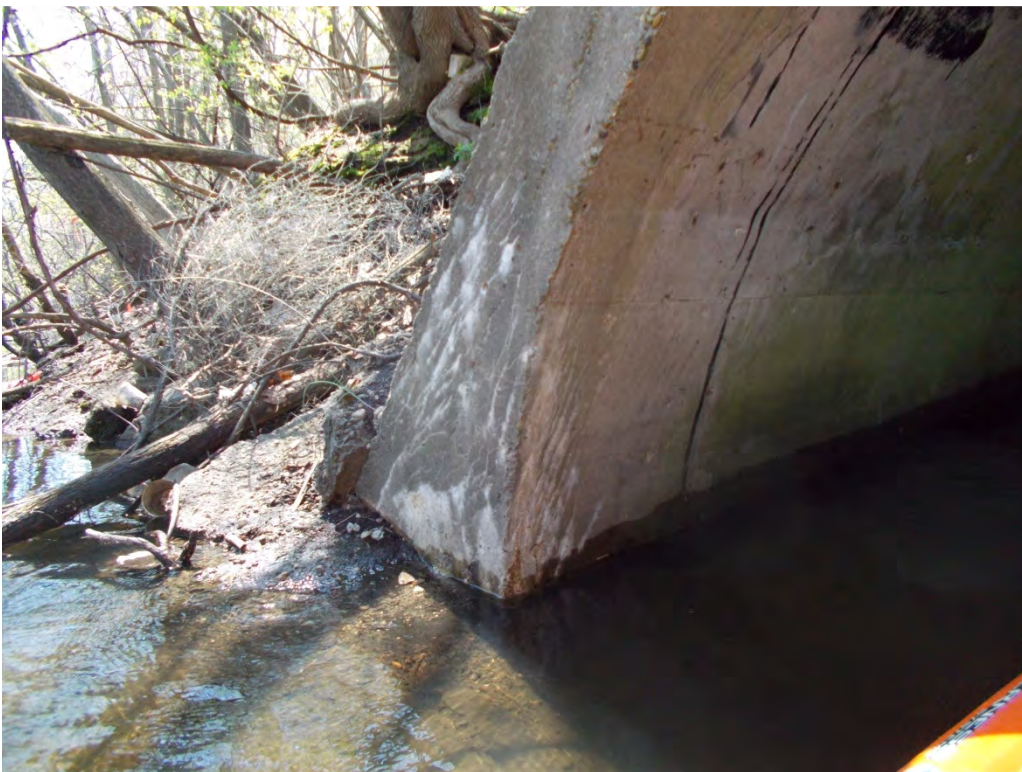
Efflorescence and delamination near the waterline

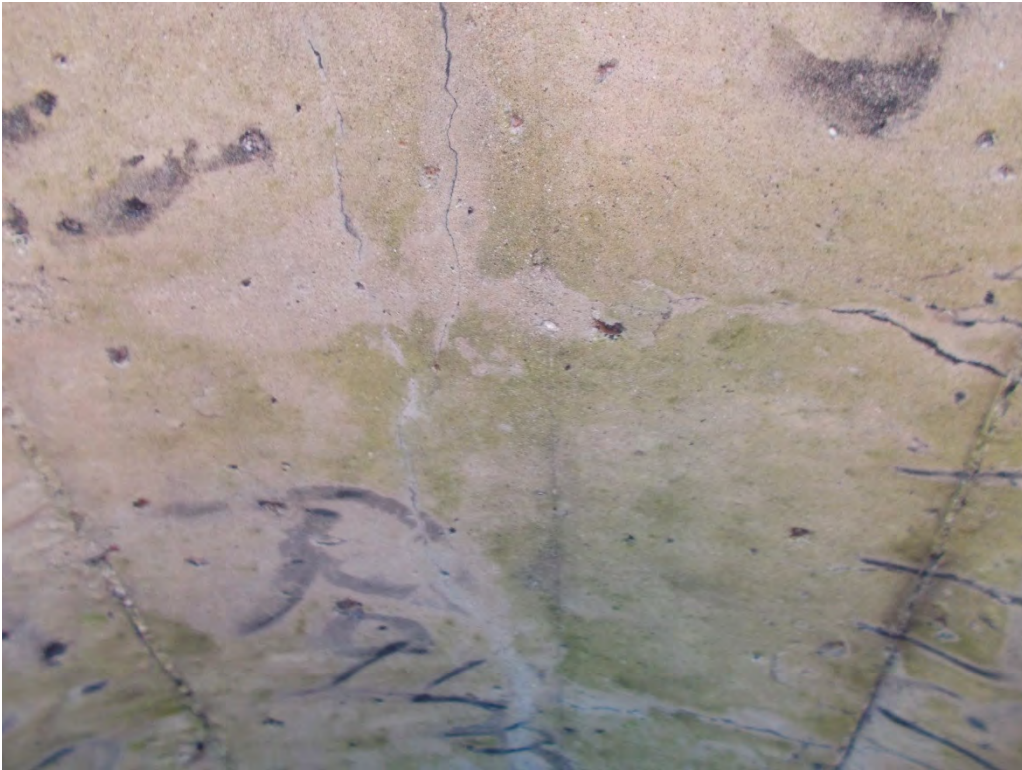
Cracking in the soffit area

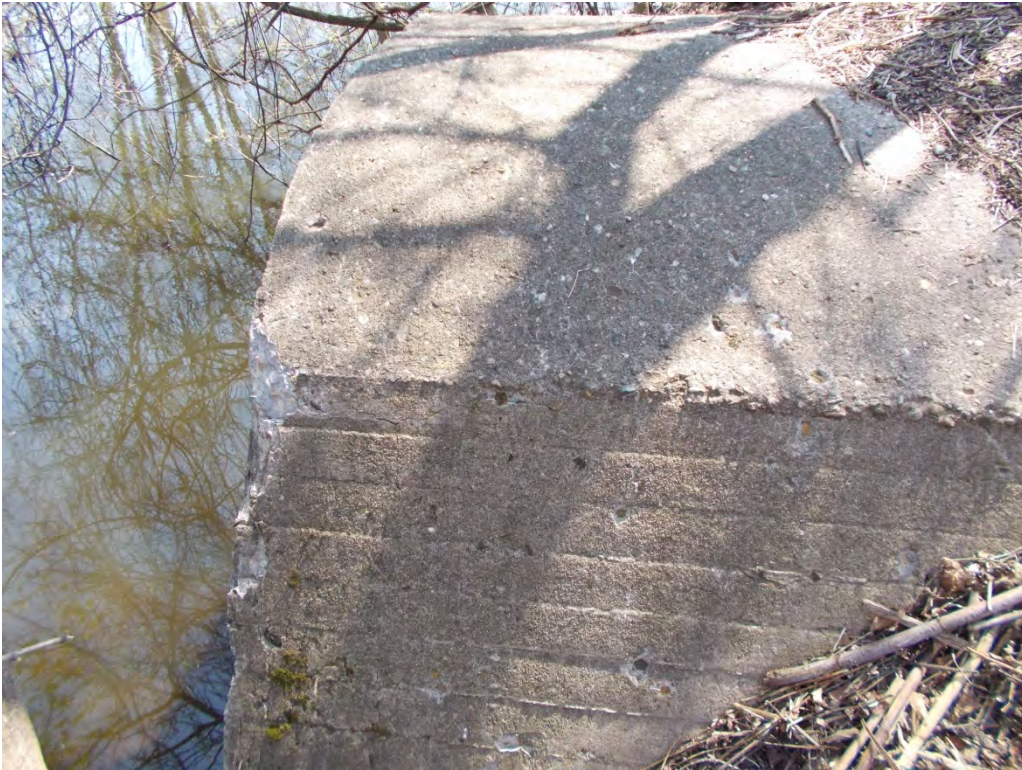
Cracking and weathering of the concrete on the northern exterior

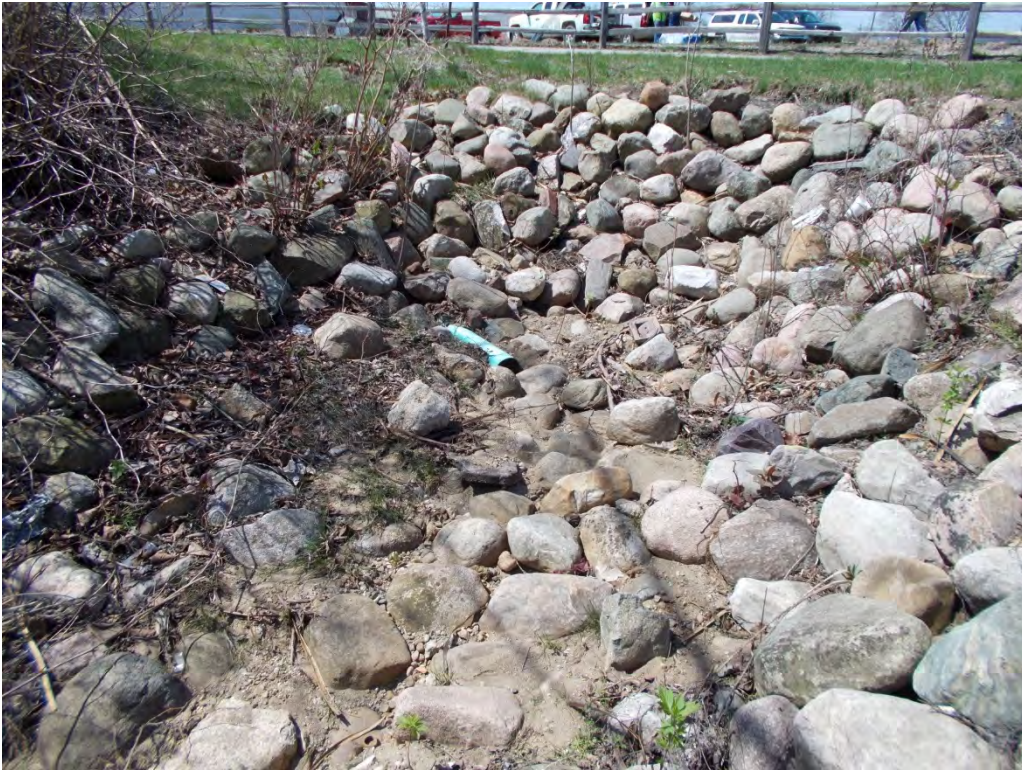
- The pipe is faded from sun exposure, but otherwise appears to be in new condition. The invert is partially buried.

View of structure from the water's edge

- The pipe itself is located back from the water's edge. Due to its limited capacity, it likely does not carry enough stormwater to warrant isolation. It should be protected from inadvertent damage during sediment removal.
- Field stone should be removed and replaced as required during sediment removal. It should be replaced on a geotextile liner to prevent erosion of the underlying soils.

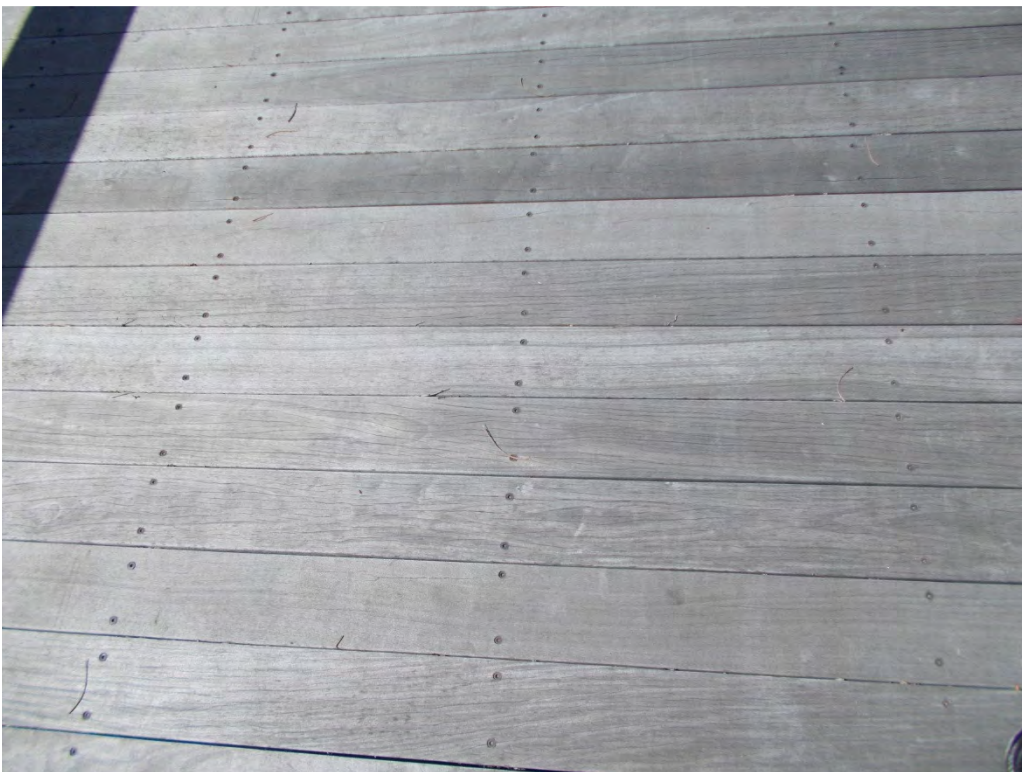
- The timber decking is weathered and has minor splitting over most of its area.
- Field stone riprap is in place around both abutments.
- The concrete sidewalk connecting to the boardwalk in the southeast is undermined approximately 2" and has cracking near its end.

Weathering and splitting of timber decking

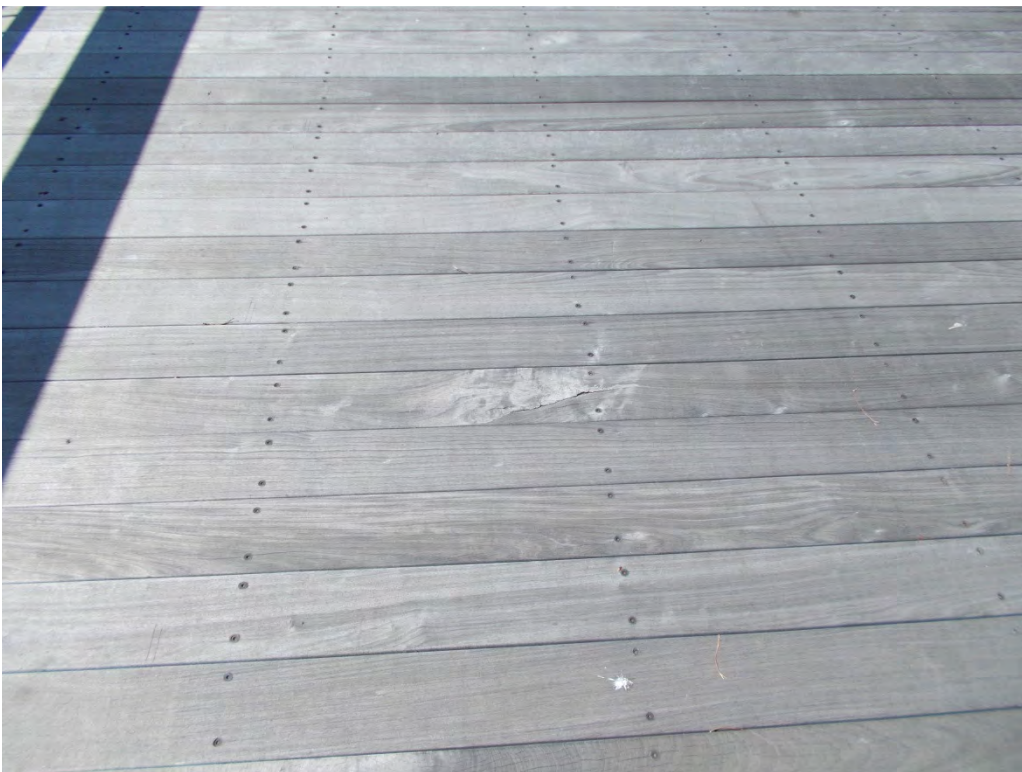
Weathering and splitting of timber decking

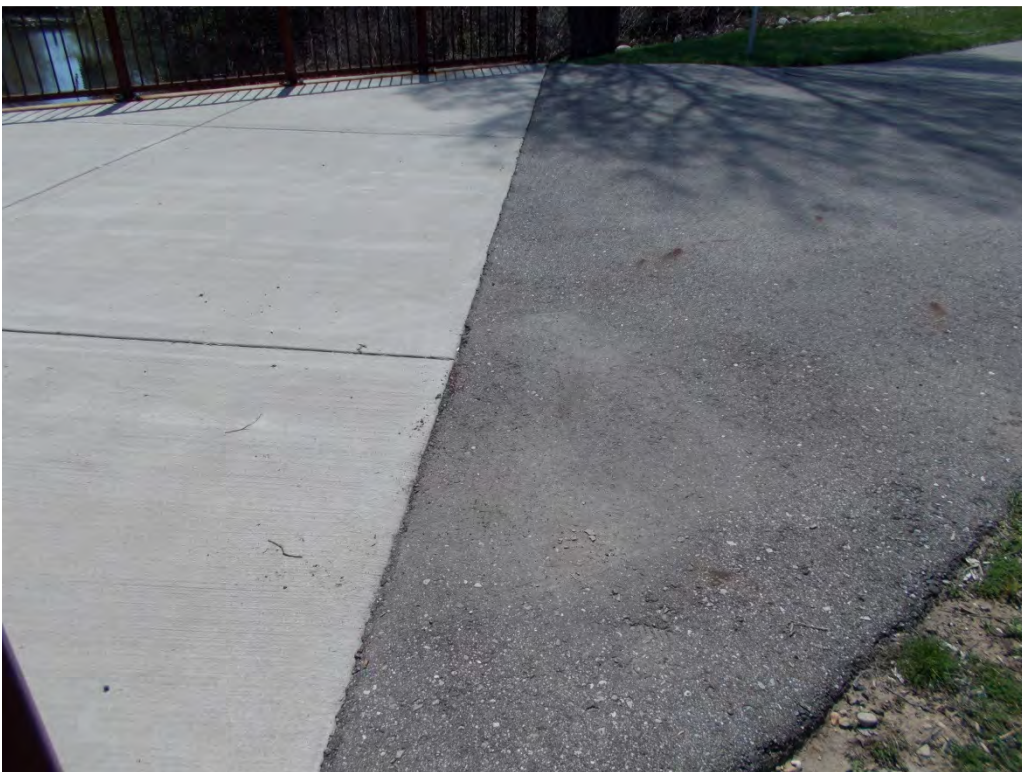
- Brush growth is encroaching on the southeast quadrant of the structure.
- The asphalt/concrete joint on the west approach is opening slightly. The asphalt has an isolated area of edge cracking in the southwest.

Separation along asphalt/concrete joint

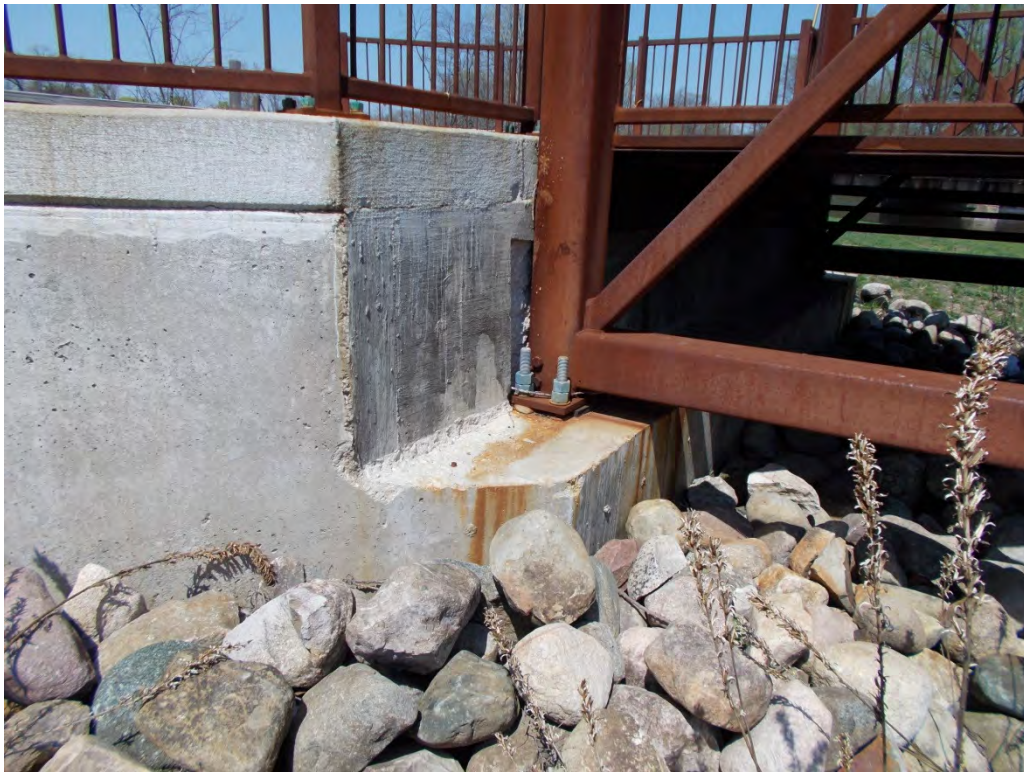
- The west backwall appears to have been sawcut/chipped to allow setting of the steel structure.
- Minor to moderate slope erosion was noted in the southwest.

Notched area of west backwall

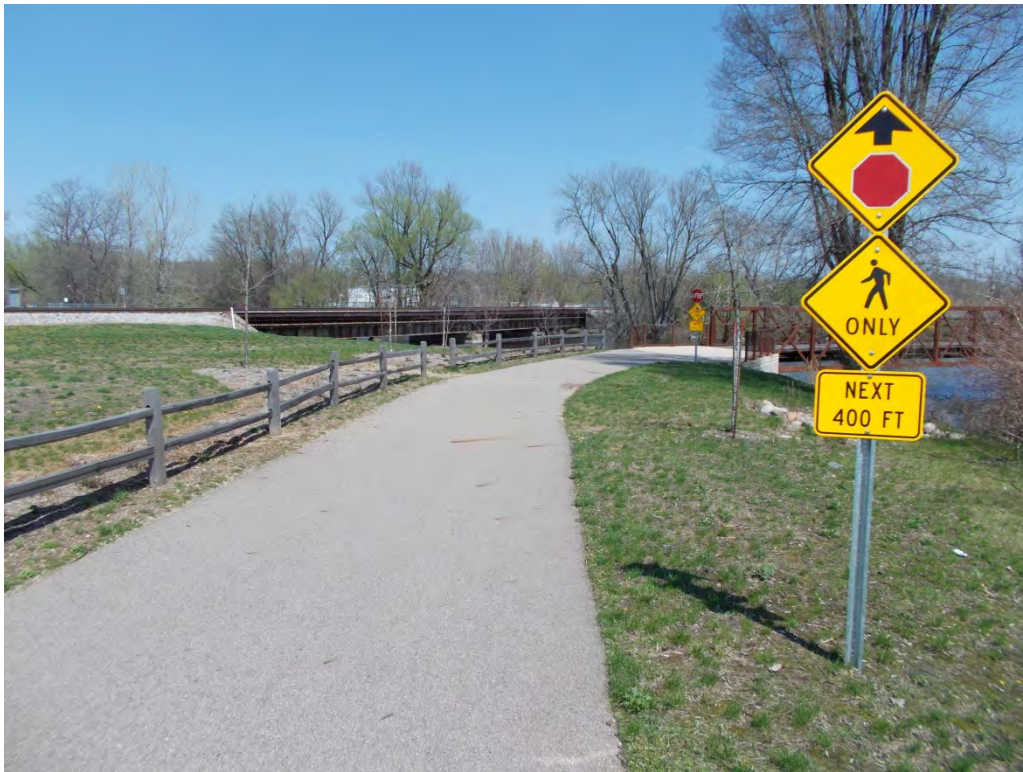
View of structure from the west approach

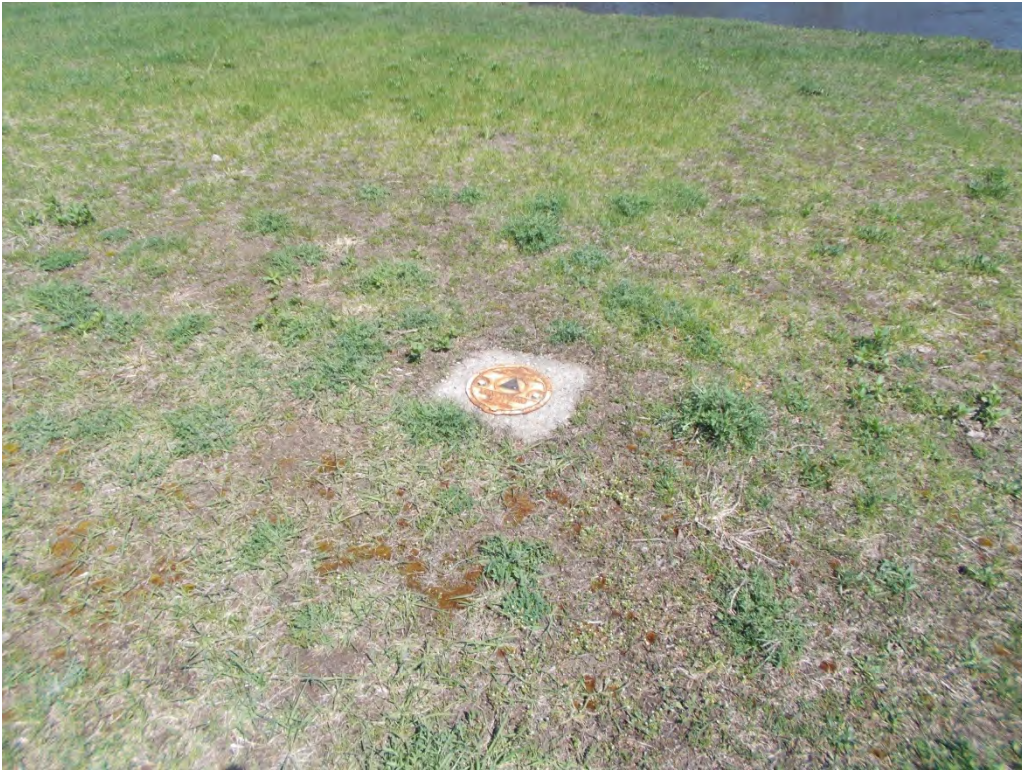
Monitoring well in the northwest

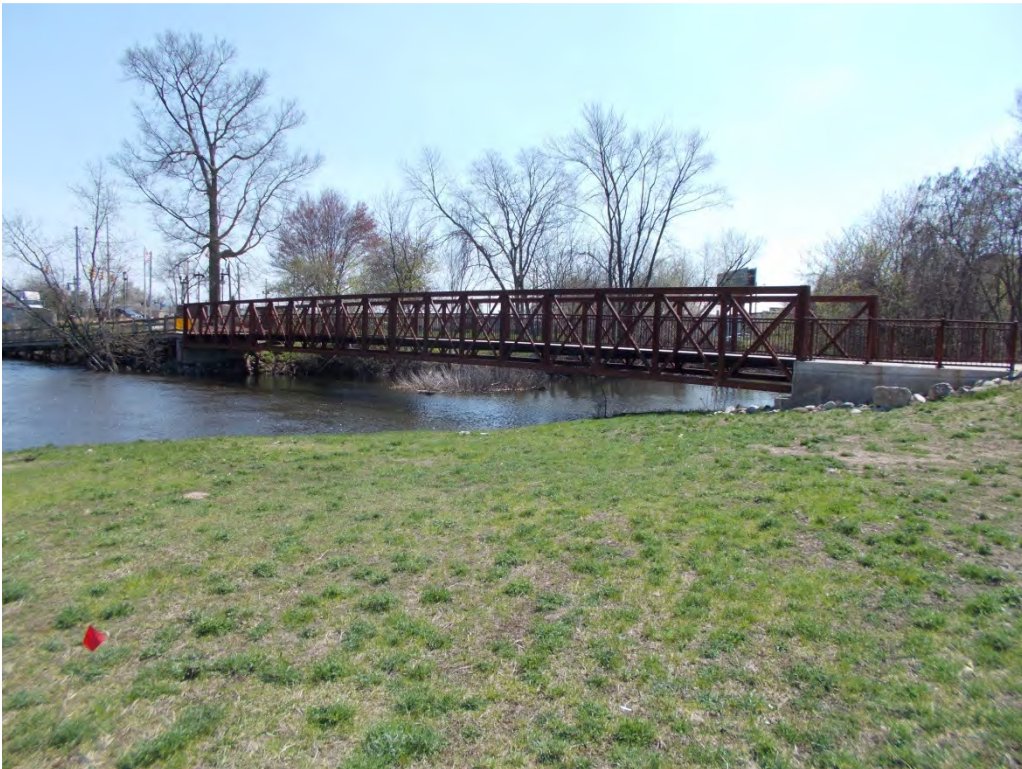
View of structure from the northwest

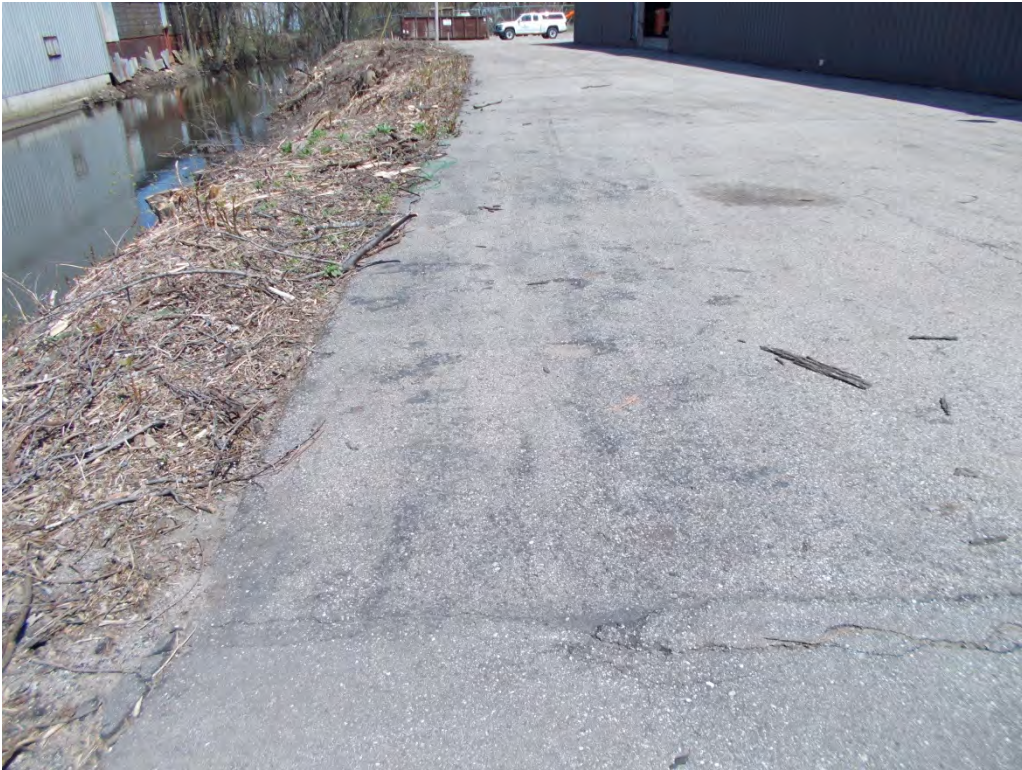
- The asphalt pavement is in fair to poor condition with cracking throughout, some of which has vegetation growth.
- Severe edge cracking and spalling was noted.
- Several areas of settlement and alligator cracking were noted.
- There is a concrete bumper at a commercial dumpster near the north end of the pavement area.

View of pavement area looking north toward SA1-B

- Repair or replace damaged areas of pavement as required.

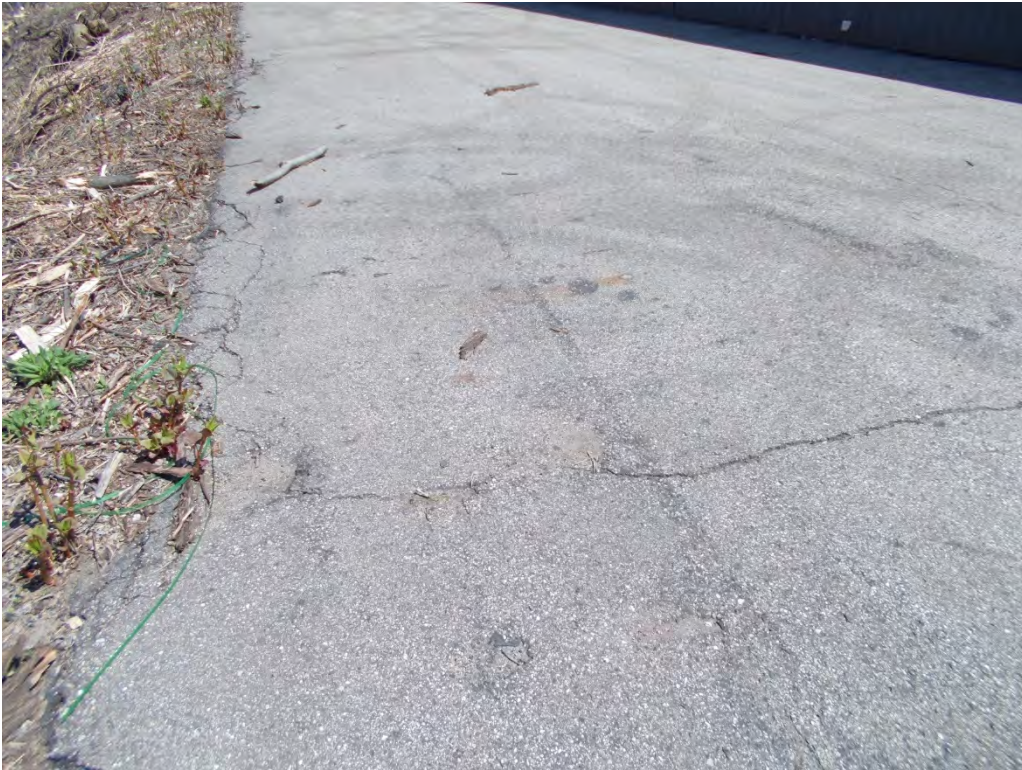
Edge cracking and random cracking in pavement

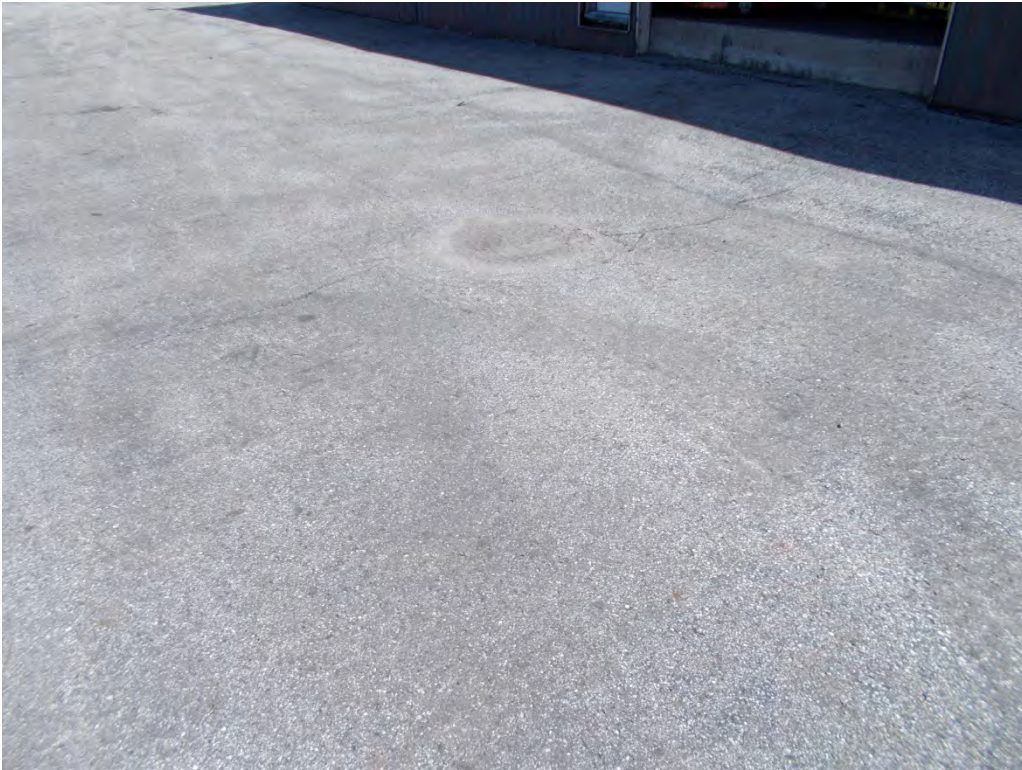
Area of severe settlement
